Environmentally Compatible Vapor-Phase Corrosion Inhibitor for Space Shuttle Hardware ©

Howard L. Novak
United Space Alliance (USA), LLC
8550 Astronaut Blvd.
Mail Stop: USK-864
Cape Canaveral, FL 32920
novakh@usasrb.ksc.nasa.gov
321-867-7054

Phillip B. Hall
NASA Marshall Space Flight Center
Mail Stop: ED 32
Marshall Space Flight Center, AL 35812
phillip.b.hall@msfc.nasa.gov
256-544-2525

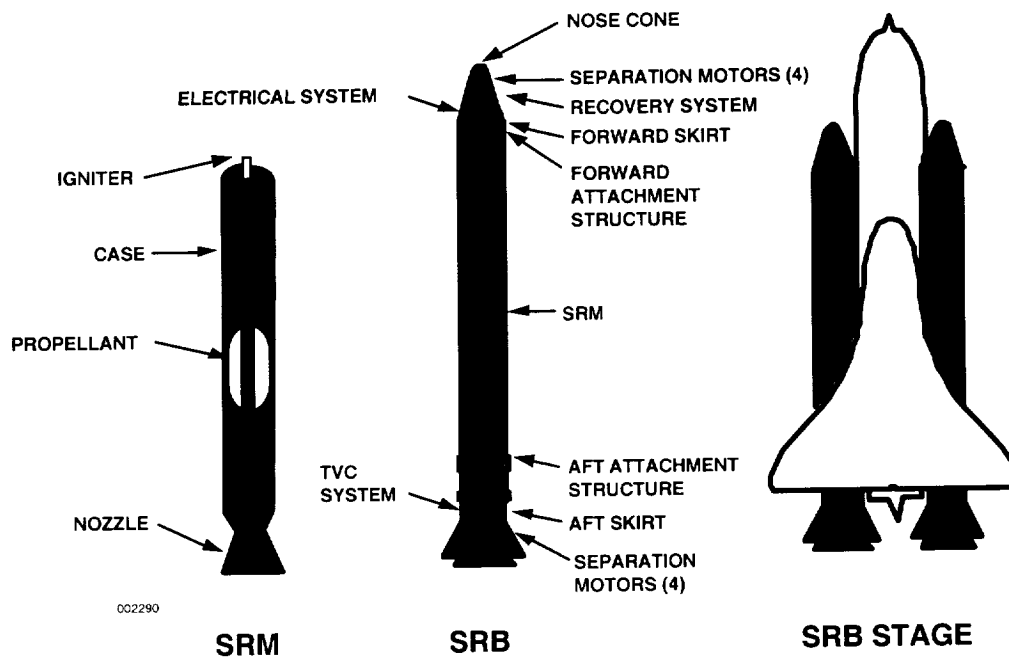
Figure 1. Space Shuttle's SRB

USA LLC is responsible for the assembly and refurbishment of the non-motor components of the SRB as part of the Space Shuttle system shown in Figures 1 and 2, and which is developed and managed by Marshall Space Flight Center (MSFC) in Huntsville, Alabama. Programs are underway to develop and evaluate environmentally acceptable LVCI's for use on aerospace flight hardware in order to eliminate and/or mitigate corrosion, and ultimately extend the useful service life of these unique and expensive hardware items. Figures 3 shows the location of both upper and lower TVC frames in the Aft Skirt of the SRB. SRB TVC frame material is made from 2219 Aluminum Alloy weldments that are final machined and painted internally and externally. Figures 4 and 5 show the internal cavities, Boss Port Plugs and general construction of Upper and Lower TVC Frames. Borescopic inspection has revealed corrosion in cavity surfaces of both Upper and Lower TVC Frames. Engineering requirements state that any visible corrosion is cause for rejection, and disallows the use of those discrepant frames, and there are significant numbers of TVC Frames that have been set aside because of internal corrosion. The initial objectives of this project were to verify the effectiveness of CORTEC LVCI 377 through the uses of the NASA Kennedy Space Center (KSC) Beach Exposure Corrosion Site, and the U. C. Davis / McClellan Nuclear Radiation Center (MNRC) located in Sacramento, CA. CORTEC also provided verification procedures for use of the LVCI in production at USA Florida Operations, with Refractometry, Titration and pH analysis. See USA LLC Copyright Agreement in References (2).

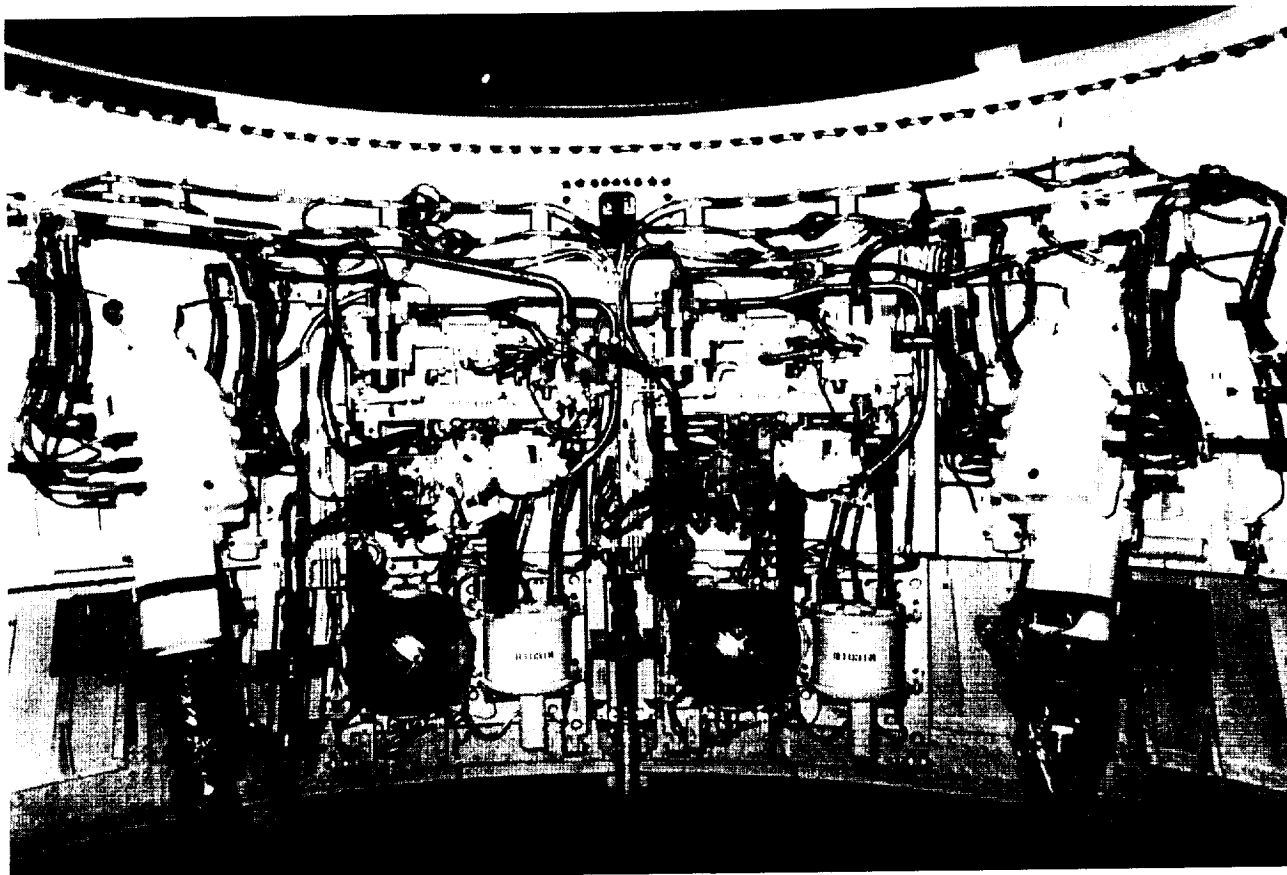
Figure 3. SRB Aft Skirt Location of TVC System

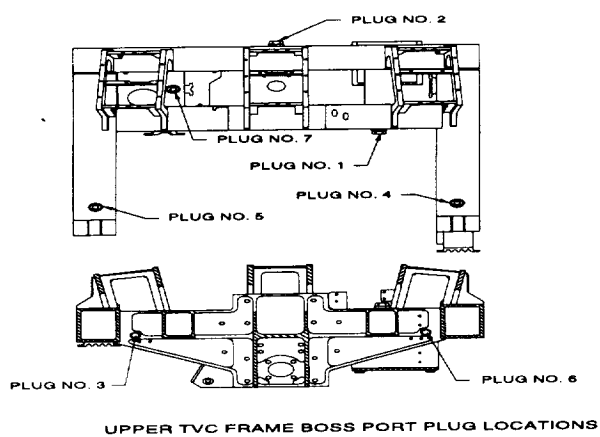
Figure 4. Sectional View of Upper TVC Frame

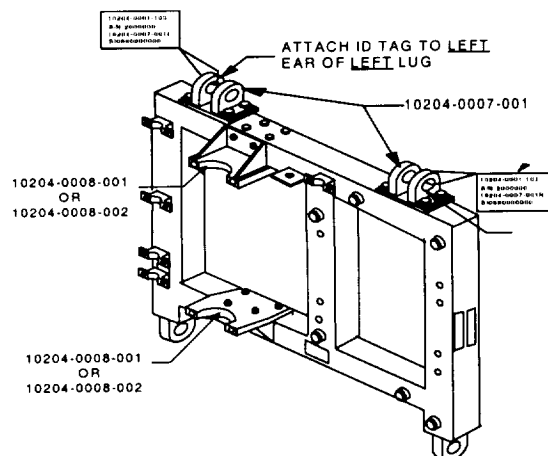
Figure 5. Construction of Lower TVC Frame

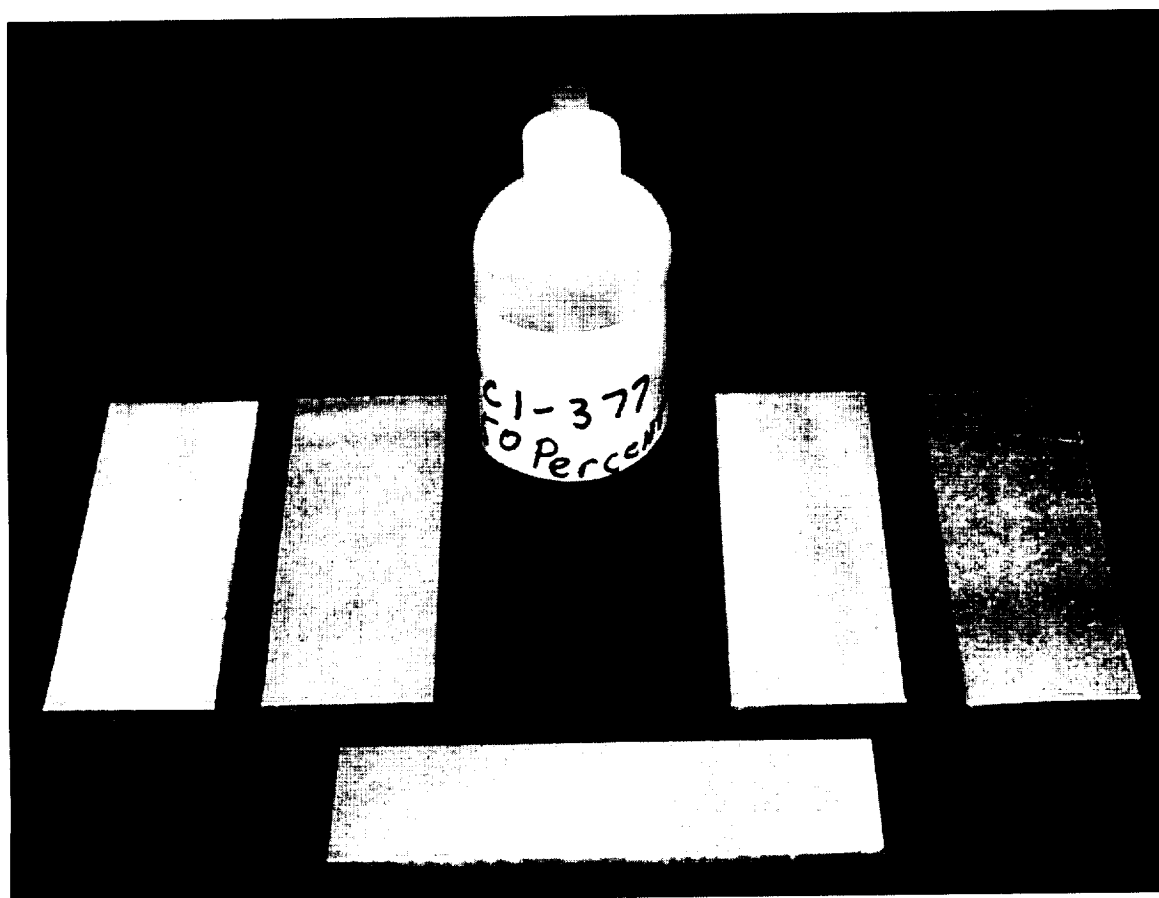
Figure 6. LVCI With Aluminum Test Coupons

The first phase of this program involved the selection and screening of environmentally compatible, non-flammable LVCI's. CORTEC Corporation produces an excellent selection of LVCI's, and two were initially selected for evaluation. Of these two, one product (LVCI 377) evaluated for environmental compatibility, stability, flammability and corrosion protection of 2219 Aluminum Alloy was selected. A non-flight TVC Frame was sectioned and used as an environmental chamber for placing 2219 -T87 Aluminum Alloy LVCI treated test coupons at the NASA KSC Beach Exposure Corrosion Site. Figure 6 shows the diluted (1 Part LVCI to 1 Part Water) LVCI used to treat the bare aluminum test coupons. Figure 7 shows the sectioned TVC Frame with coupons installed.

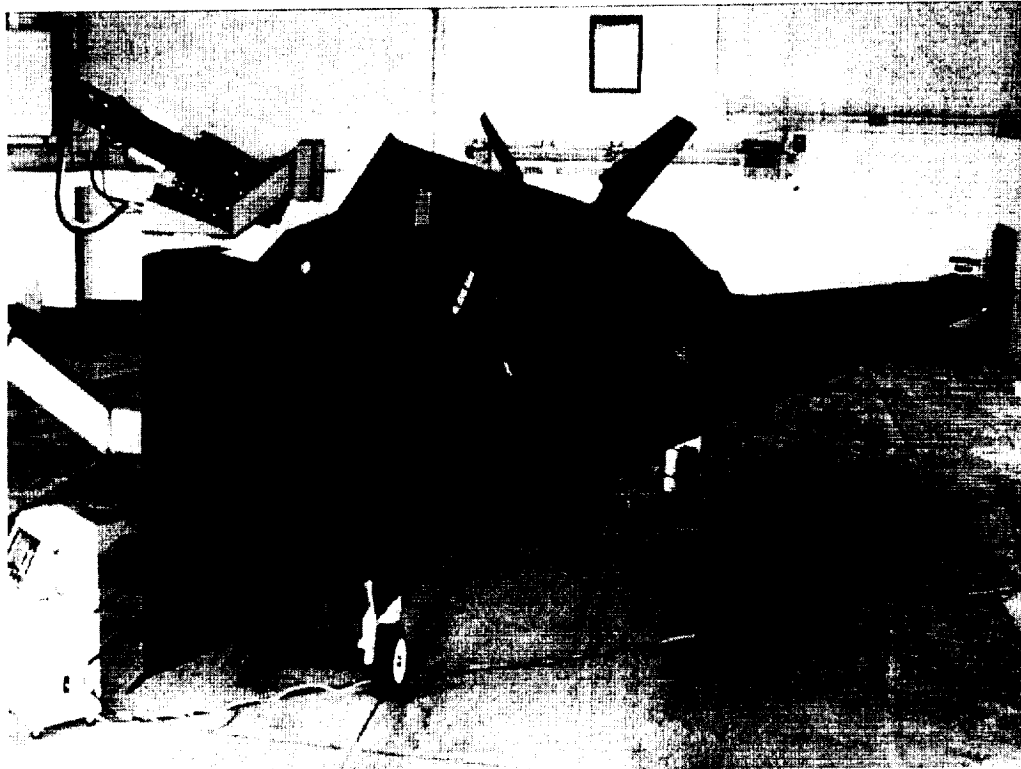
Figure 8. Radiographic Facility at McClellan Nuclear Radiation Facility

The MNRC has a TRIGA Reactor that produces sufficient thermal neutrons and complementary robotic work cells that allows for corrosion evaluation and accurate positioning of critical fighter and cargo aircraft parts. USA LLC was able to contract with MNRC to evaluate internal corrosion of Non-Flight SRB TVC Frames, and hopefully establish capability for potential future evaluation of SRB flight hardware. Two (2) Upper, and two (2) Lower TVC non-flight frames were used for Neutron Radiography (N-Ray) corrosion evaluation. Initial N-Ray Baselineing was performed on untreated frames. The TVC frame cavities were then flushed with Grade A (Deionized) water, emptied, and then filled with LVCI. The LVCI was allowed to penetrate for one hour, with rotation of the frame to guarantee LVCI coverage. The LVCI was then pumped/vacuumed from the cavities, and Boss Port Plugs installed. Another series of N-Radiographs were made after the initial LVCI application. Subsequent N-Ray evaluations were made after 3 months, and then after 8 months exposure to the LVCI. MNRC was able to produce N-Radiographs using Film and also real-time with recordings on Video Tape. Figure 8 shows some typical work being done at the MNRC.

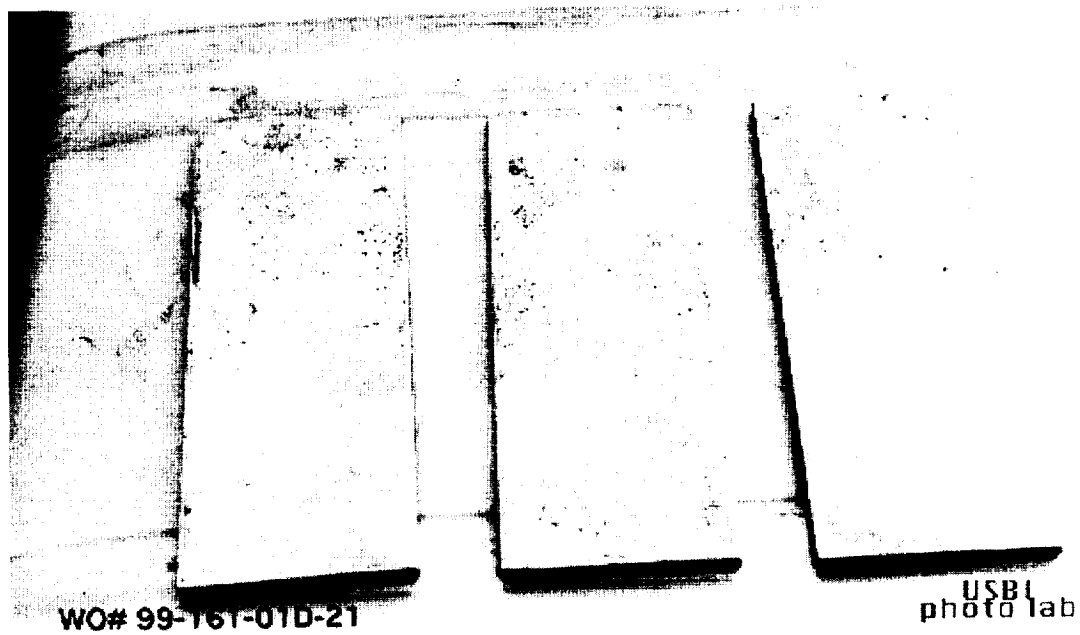
Figure 9. Aluminum Test Coupons after 7 Months Beach Exposure

NASA KSC Beach Exposure Corrosion Site evaluations and documentation were made on a regular basis. TVC frames were loosely covered with a secured plastic wrap, and allowed to remain exposed for almost a year. There was virtually no corrosion on the test coupons treated with the LVCI. One TVC frame exposed to hurricane force winds after 10 months exposure lost its plastic cover, and with internal test coupons sand blasted; experienced premature corrosion immediately after. Figure 9 shows typical surface conditions of aluminum test coupons after 7 months beach exposure. It should be noted that the slight brown color intermittently seen on the test coupon's surfaces, are trace amounts of LVCI that dried to a somewhat greater film thickness. Essentially, the test coupons were corrosion free. In many cases during evaluation of the LVCI effectiveness, residual water was found inside the TVC frame cavities, with no effect on corrosion of the test coupons. It would be very difficult to duplicate the environmental exposure given to the test coupons at the NASA KSC Beach Exposure Corrosion Site. Testing was also performed using ASTM B 117 (1) Neutral Salt Fog testing procedure as well as Temperature-Humidity cycling in an environmental test chamber. None of these tests revealed the true capability of the CORTEC LVCI 377, as did the NASA KSC Beach Exposure Corrosion Site evaluations.
